Report Number: WUCS-90-19

BTC Modifications

This paper describes the modification made to the design of the Broadcast Translation Circuit based on test results from the first fabrication run. The document updates WUCS-89-52, which outlines the design of the BTC in full detail.

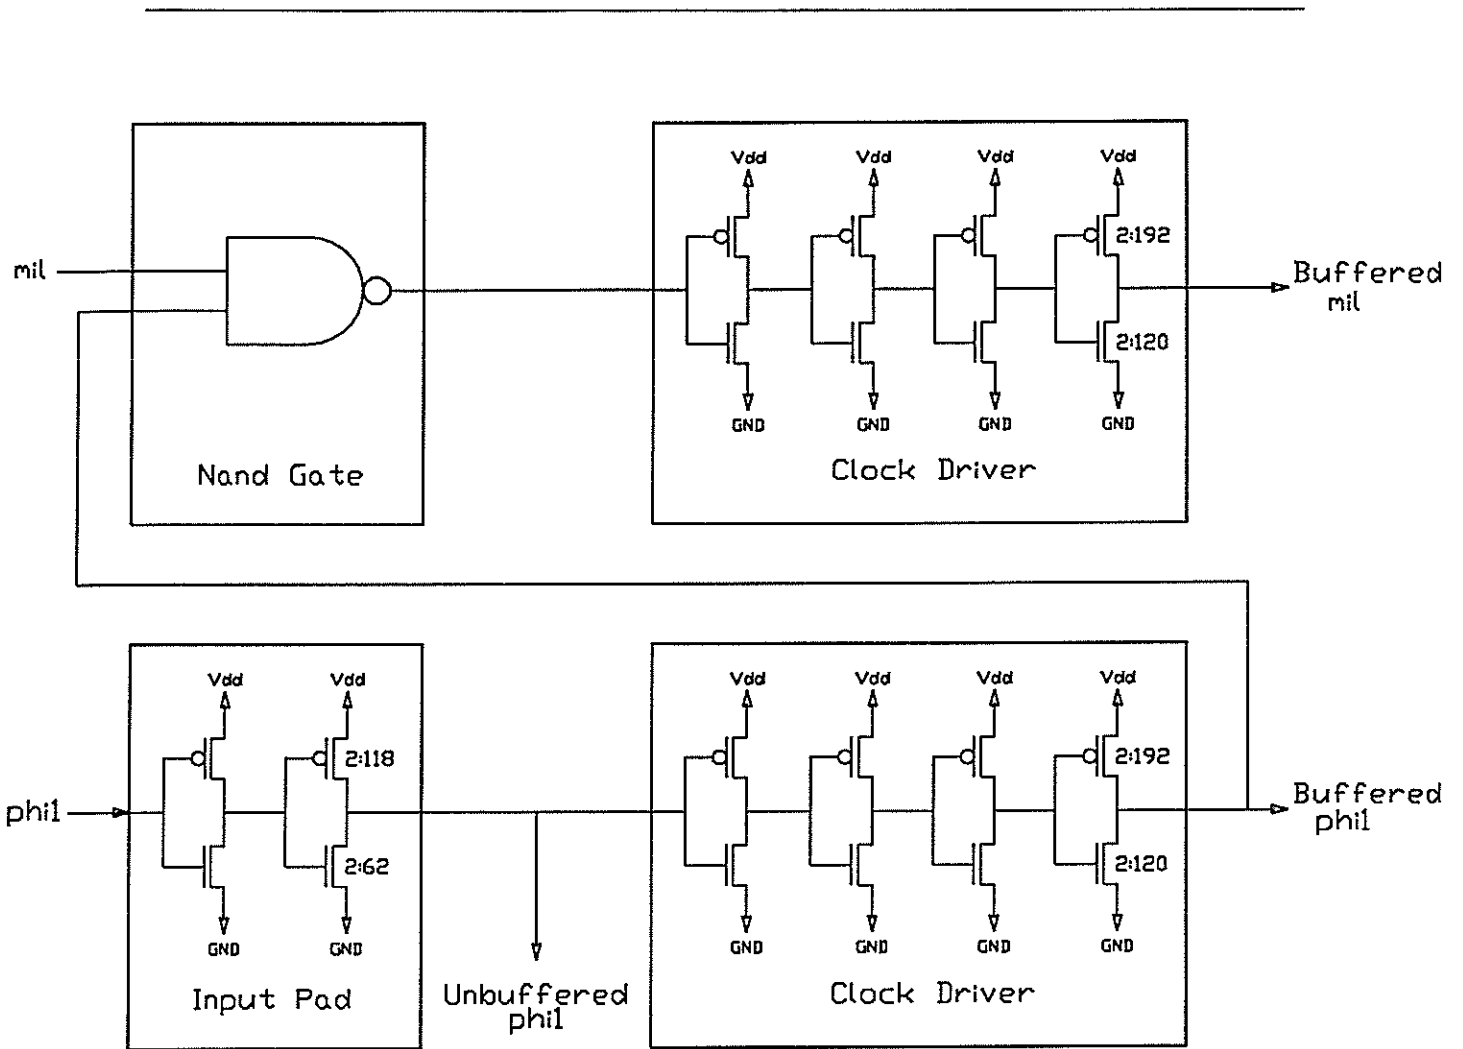
Figure 4. Block Diagram of BTT Latching Signals

The BTT was unable to latch incoming data at high speed because the shift registers at the end of the interface regenerated the signal with respect to the clock. The *mil* latch signal was buffered by a large driver which delayed it so that it arrived while data was changing. Figure 4 shows a block diagram of how the latching signals for the BTT were set up. The most robust solution to reducing the delay experienced by signals such as *mil*, *lat* and *ld* is to qualify them with unbuffered $\phi 1$ instead of buffered $\phi 1$ because that reduces about 5 ns from the delay which satisfies the required constraints. A *CAZM* simulation showed that after the change *mil* did not overlap with the following $\phi 2$ any more at the simulation speed of 42MHz.

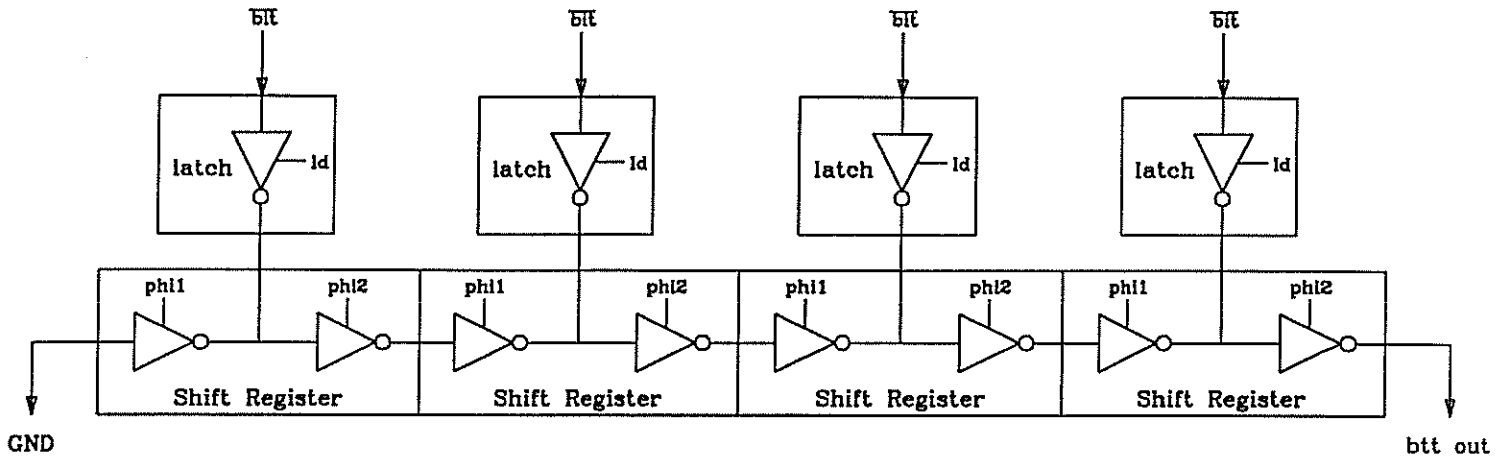
Figure 5. BTT Output Circuitry

A block diagram of the downstream portion of the BTT in version 1. of the BTC appears in Figure 5.

This shows that the *PISO* shift registers are qualified by an ordinary clock. The signal *ld* is qualified by a $\phi 1$ and it appears that the output node of the downstream *PISO* latches are driven not only by the latches, but also by the preceding stage. This would cause a set of unresolved nodes. The chip did not exhibit an error because of the skew between the signals but with the modified *ld* this would cause a problem. Thus, a new signal was created called *ldop* that would be asserted during $\phi 1$ except during the clock cycle that *ld* was asserted. This signal was used in place of $\phi 1$ in the same configuration that appears in Figure 5. Figure 6 shows the relationship between *ld*, *ldop* and the clocks.
