### BTC Modifications

## **BTC MODIFICATIONS**

**WUCS-90-19**

**This paper describes the modifications made to the design of the Broadcast Translation Circuit based on test results from the first fabrication run. The document updates document WUCS-89-52, which outlines the design of the BTC in full detail. This version of the BTC will be fabricated using a 2.0  $\mu\text{m}$  N-well CMOS process.**

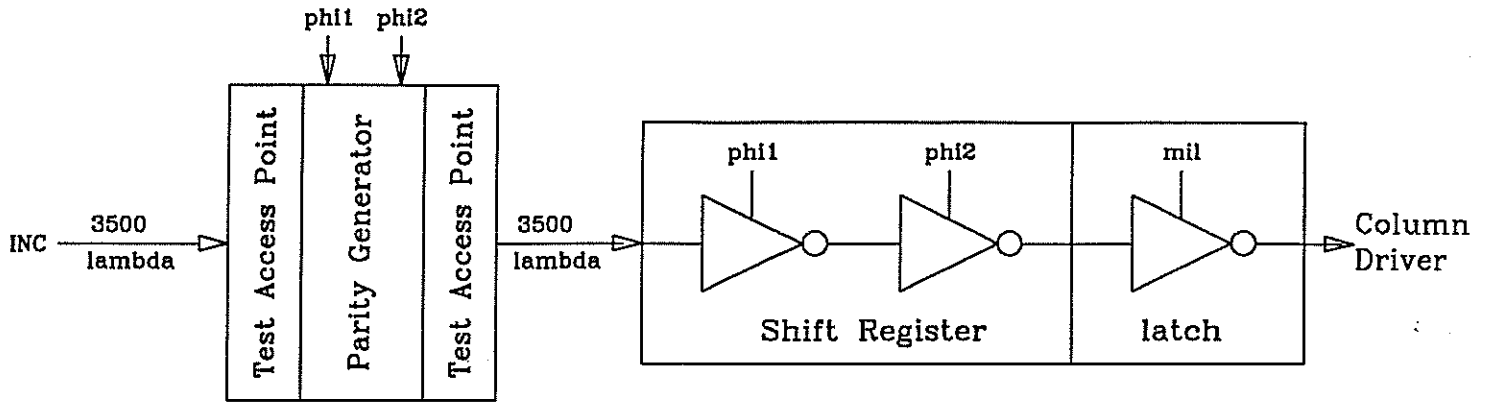
Figure 1. INC to BTT Upstream Data interface

The Tektronix LV500 may be programmed to run different parts of an input pattern at different frequencies. A test where all write BTT packets were processed at 21MHz and all other packets processed at 25MHz, yielded correct output data. This implied that it was not possible to write to the BTT at 25MHz and also that this appeared to be the only critical malfunction in the circuit. Also, since it was possible to read data from the BTT at 25MHz, both the *pt* and address signal to it functioned correctly. This left only the upstream data path to the BTT. A block diagram of this data path is given in Figure 1.

The parity generator regenerates the signal about halfway down the path. The shift registers before the latches qualified by *mil* also perform a complete regeneration. CAZM showed that a combination of two factors may have caused the failure, and both are listed below. All CAZM results are from simulation at 42MHz because no failures were observed at lower frequencies.

- The *mil* signal was asserted during  $\phi 2$ , i.e. while data was changing.
- The first byte of the 4-byte serial data was not latched by *pgen* due to the set-up delay from *INC* and a slow test access point design.

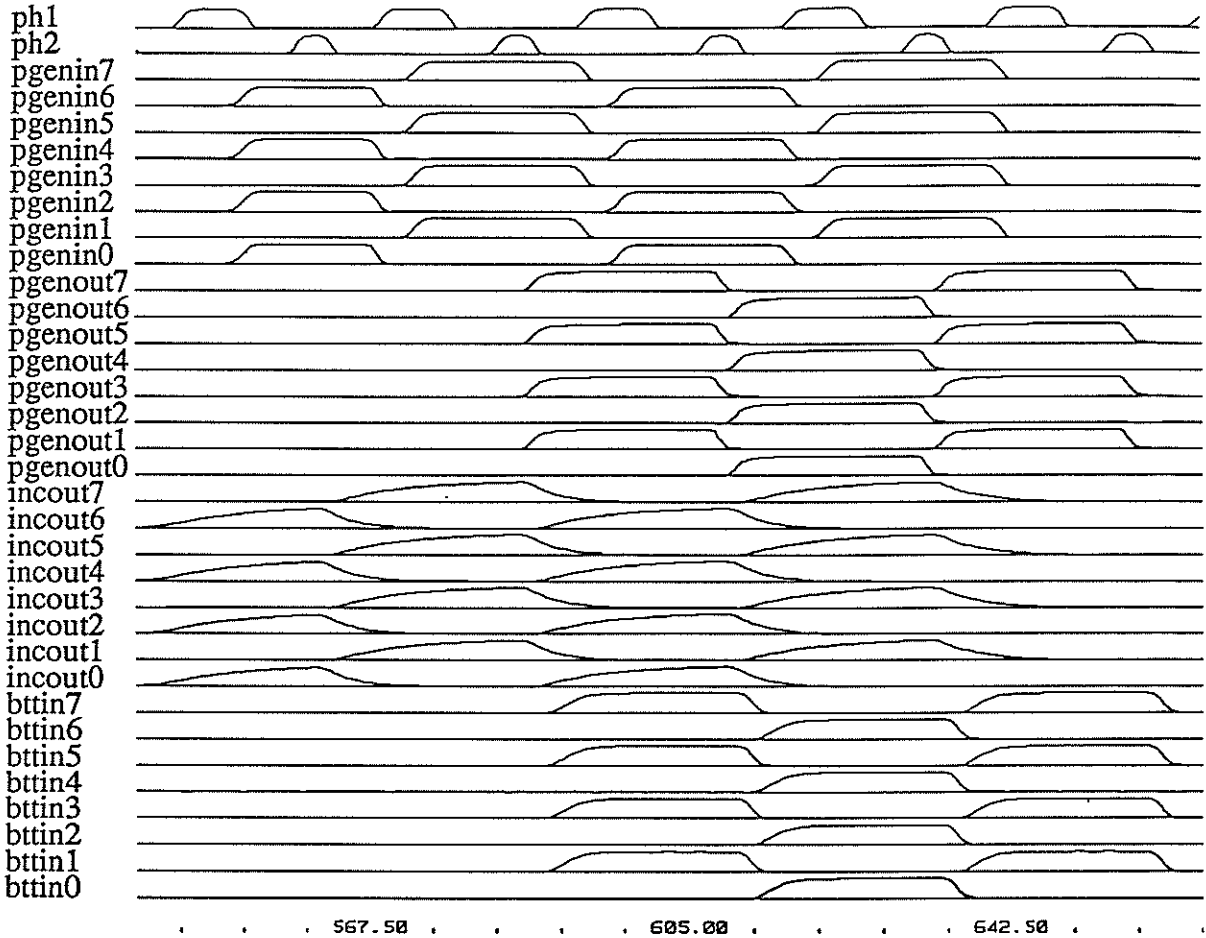
Figure 3. Loss of first byte of Upstream BTT data

Figure 2 shows the *mil* signal with respect to the clocks. Figure 3 shows the loss of the first byte of data. Notice that the first byte of data at the input to the parity generator arrives at the trailing edge of  $\phi_1$ , and pgen does not register it. Both of these factors confirmed the failure observed on the device itself.

The identical data test is important. When all four bytes were the same, data was read out of the BTT correctly. This works because data was not being changed while the signals were latched by *pgen* and while *mil* was asserted. It rules out the concern about the integrity of the memory cells and their control. The interval  $\phi_{21}$  along with the lengths of  $\phi_1$  and  $\phi_2$  is approximately the time available to latch a signal. This interval is kept constant at a lower operational speed and the test is performed again. The results do not change providing confirmation of the proposed explanation of the failure.

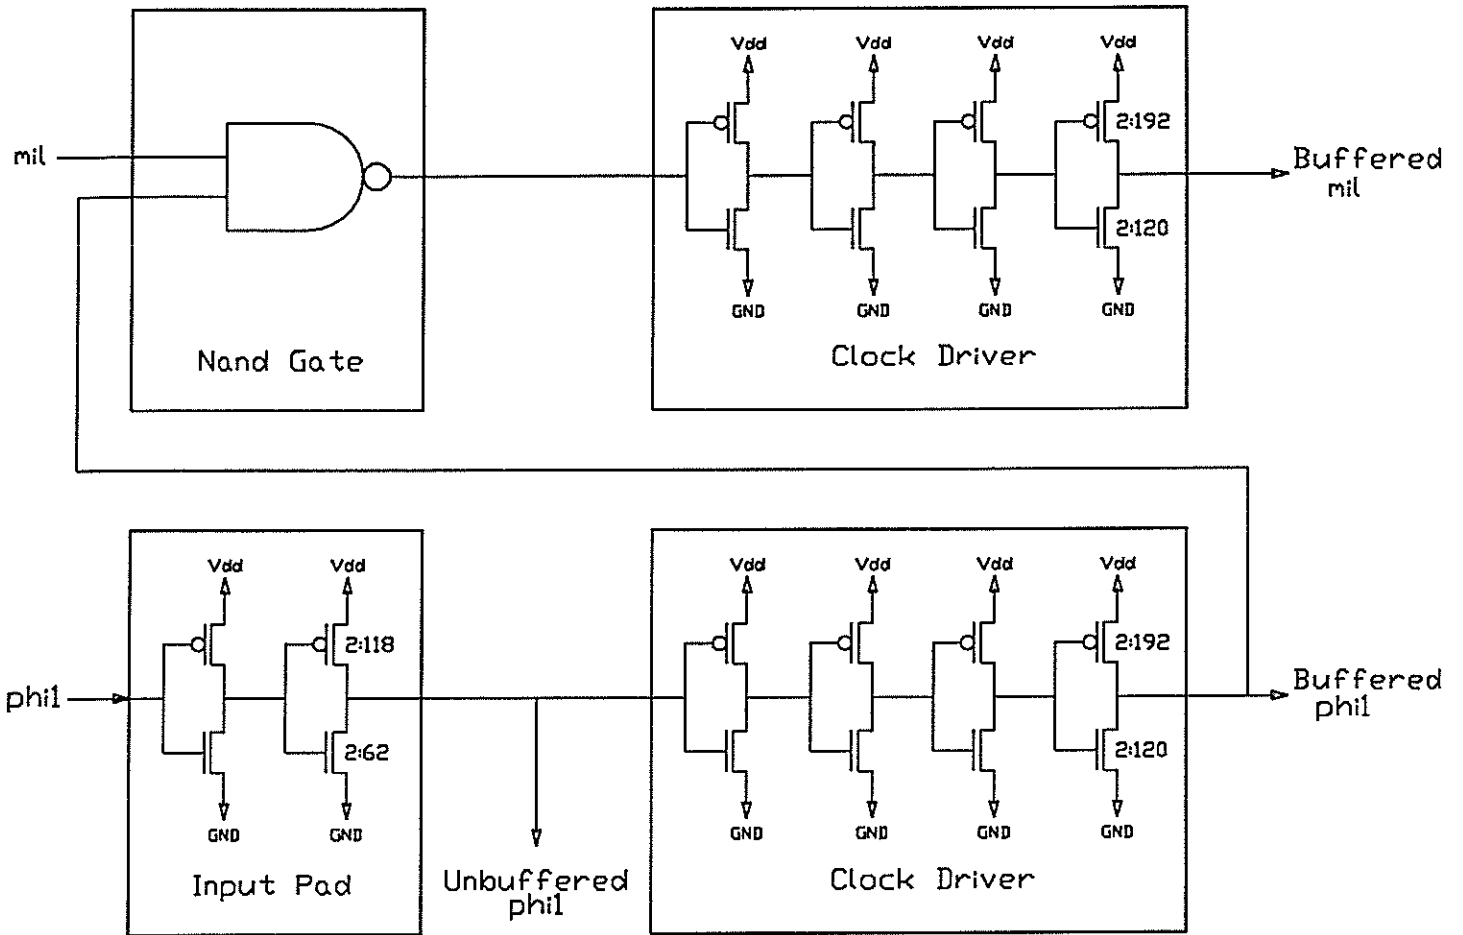
Figure 4. Block Diagram of BTT Latching Signals

The BTT was unable to latch incoming data at high speed because the shift registers at the end of the interface regenerated the signal with respect to the clock. The *mil* latch signal was buffered by a large driver which delayed it so that it arrived while data was changing. Figure 4 shows a block diagram of how the latching signals for the BTT were set up. The most robust solution to reducing the delay experienced by signals such as *mil*, *lat* and *ld* is to qualify them with unbuffered  $\phi 1$  instead of buffered  $\phi 1$  because that reduces about 5 ns from the delay which satisfies the required constraints. A *CAZM* simulation showed that after the change *mil* did not overlap with the following  $\phi 2$  any more at the simulation speed of 42MHz.

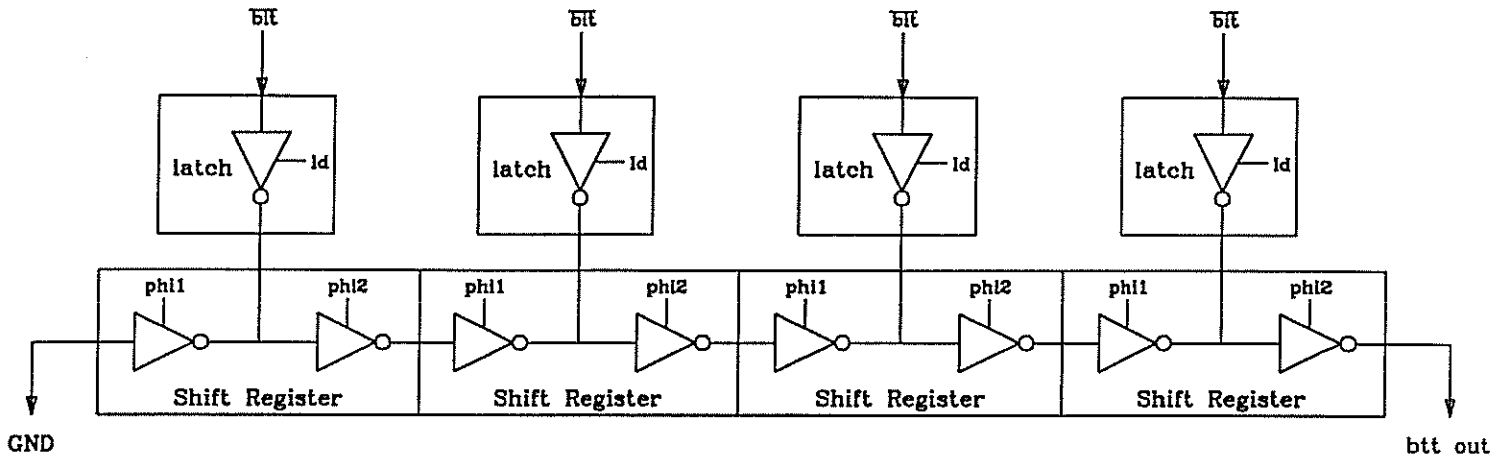
Figure 5. BTT Output Circuitry

A block diagram of the downstream portion of the BTT in version 1. of the BTC appears in Figure 5.

This shows that the *PISO* shift registers are qualified by an ordinary clock. The signal *ld* is qualified by a  $\phi 1$  and it appears that the output node of the downstream *PISO* latches are driven not only by the latches, but also by the preceding stage. This would cause a set of unresolved nodes. The chip did not exhibit an error because of the skew between the signals but with the modified *ld* this would cause a problem. Thus, a new signal was created called *ldop* that would be asserted during  $\phi 1$  except during the clock cycle that *ld* was asserted. This signal was used in place of  $\phi 1$  in the same configuration that appears in Figure 5. Figure 6 shows the relationship between *ld*, *ldop* and the clocks.

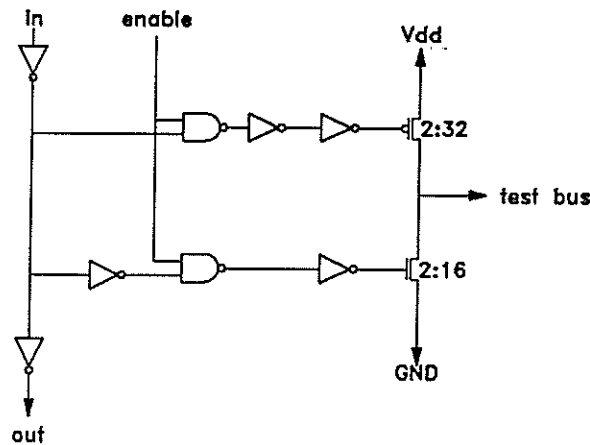
Figure 7. New Tap Design

All CAZM simulations showed an appreciable delay through the test access points. A block diagram of a tap is provided in Figure 13 of WUCS-89-52. The multiplexor on the input side does not give any extra drive, and the signal entering a tap has to charge

the capacitance associated with all three inverter cells connected to the output node of the multiplexor. This causes an appreciable delay which given the results from device testing of PP3 calls for redesign.

As mentioned before the original tap design was found to be inadequate. A new design was suggested that would remove the function that allowed the user to put data from the pins directly onto an internal bus. The circuitry associated with a single line passing through a test access point is shown in Figure 7. It has the nice property that all internal nodes of the tap are driven from within the tap itself.

This design change also resulted in replacement of all bidirectional pads on the chip by output pads, in removal of all the multiplexer arrangements dealing with bidirectional signals, and in removal of the direction signals controlling the three test buses.
