Ricola Kräuterzentrum (herb center)

case study
By Tian Lan

Location: Laufen, Switzerland

Material of interest: Loam Wall

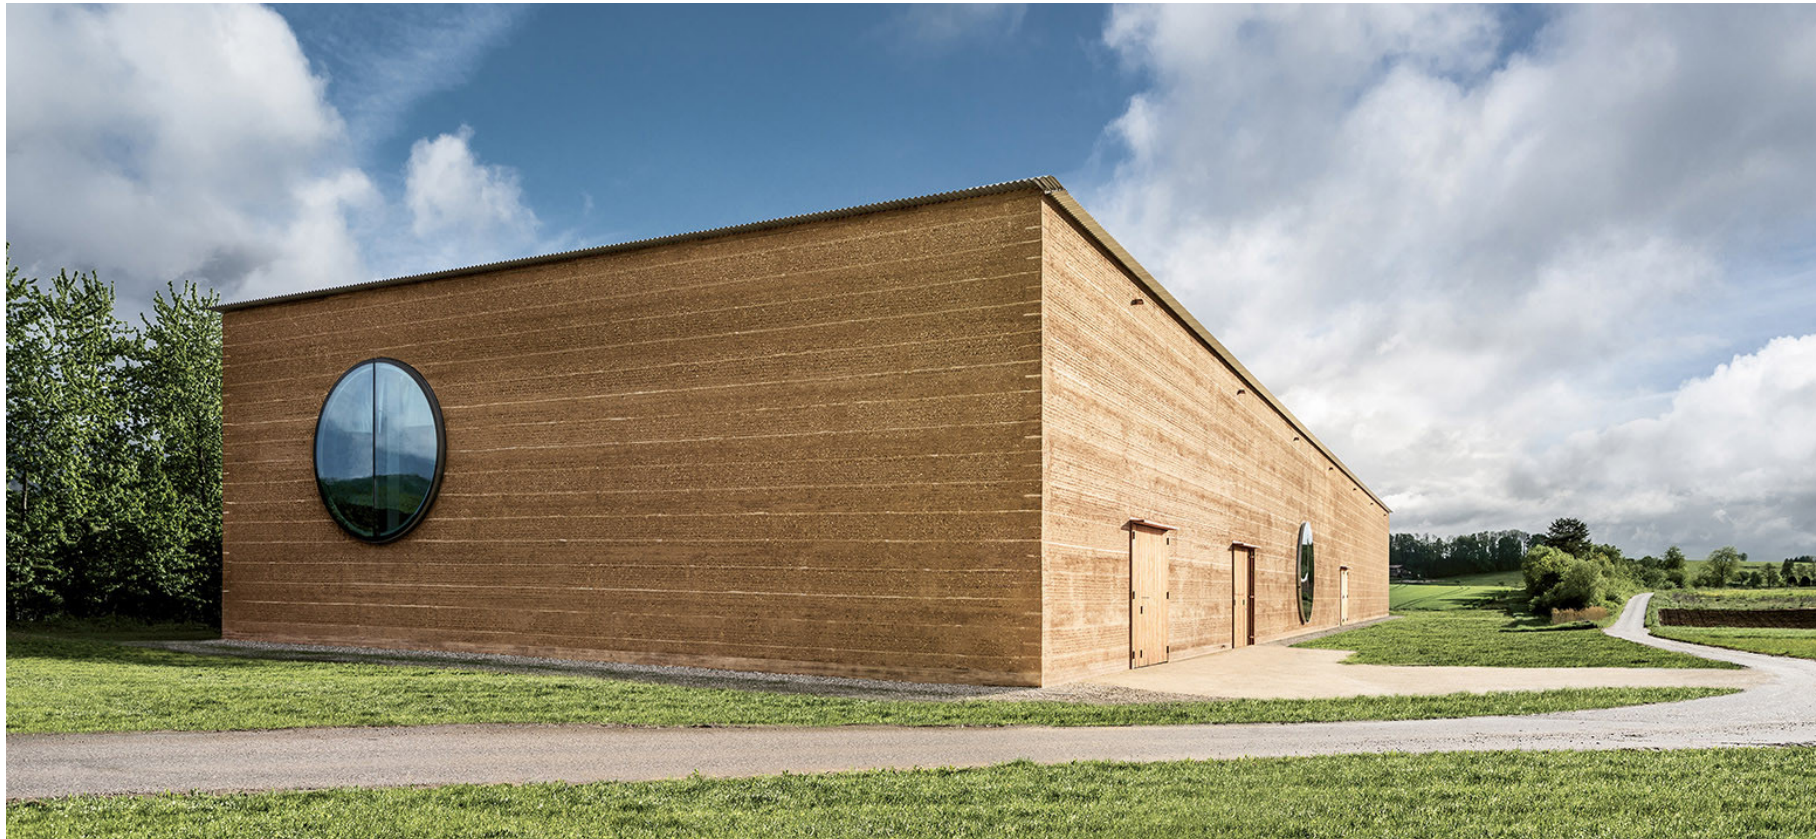
Application: Exterior Wall

Properties of material: Clay, marl and material excavated on site are mixed and compacted in a formwork and then layered in blocks to build the walls. Thanks to the plasticity of the loam, the seams can be retouched giving the overall structure a homogeneous appearance. To arrest erosion caused by wind and rain, a trass mortar achieved mixing volcanic tuff (trass) with lime, is compacted every 8 layers of earth directly in the formwork.
