# Museum of Fire in Zory

case study  
By Larissa Sattler

Location: Zory, Poland

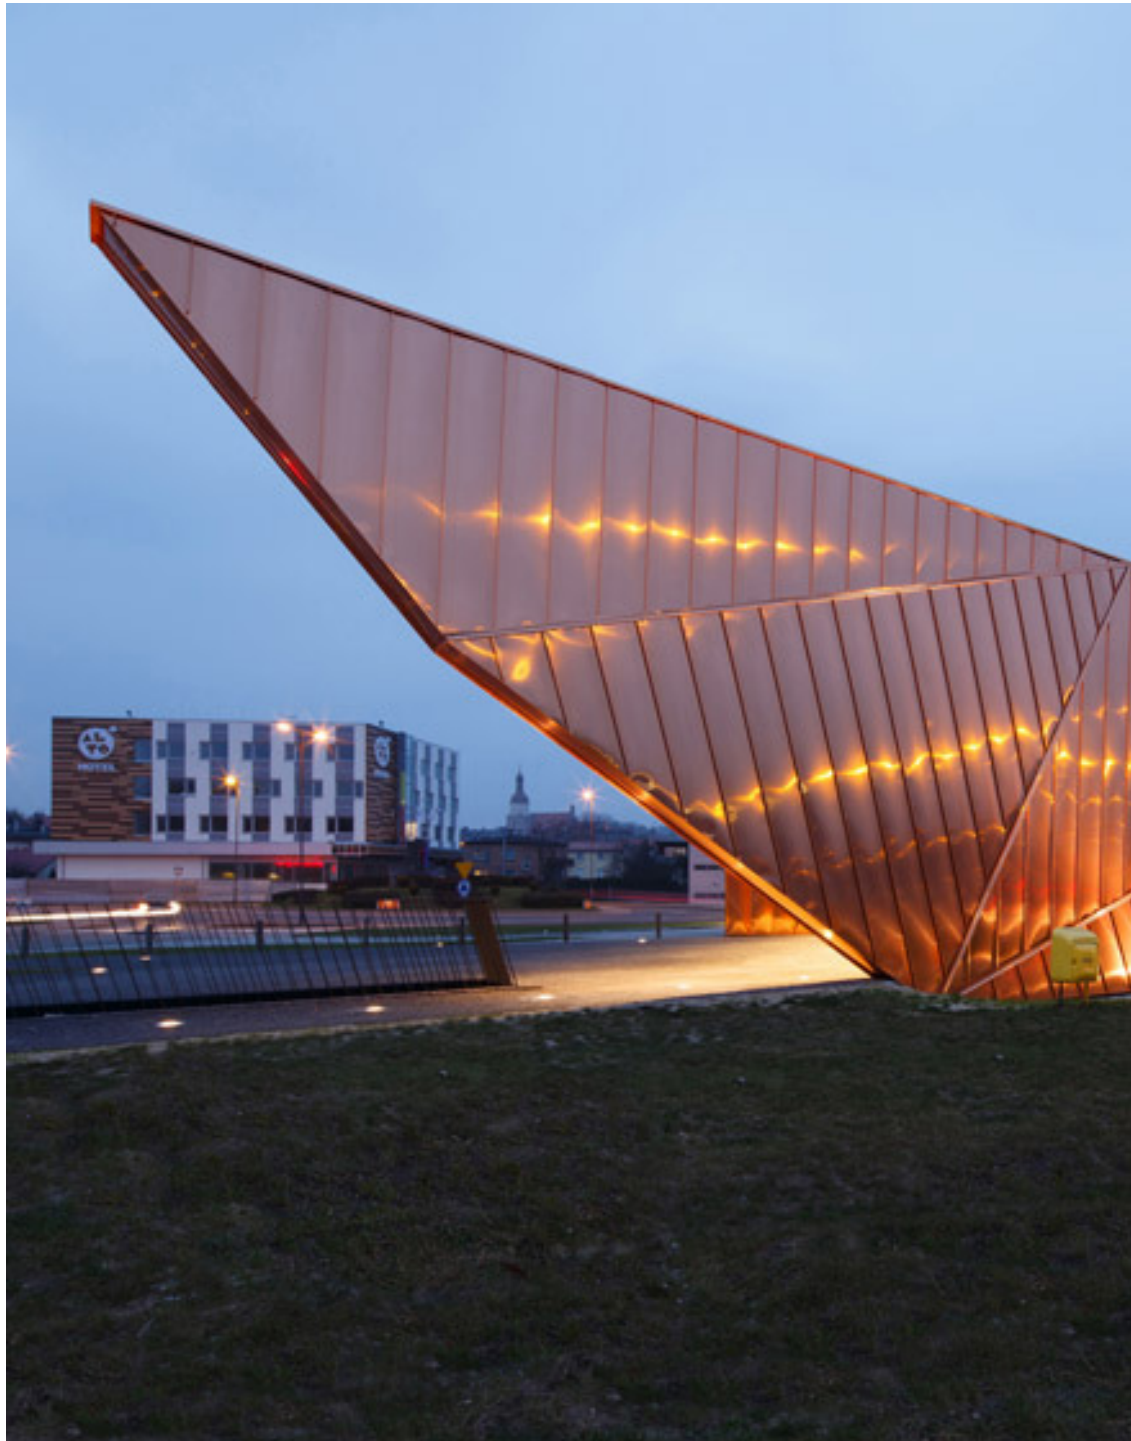
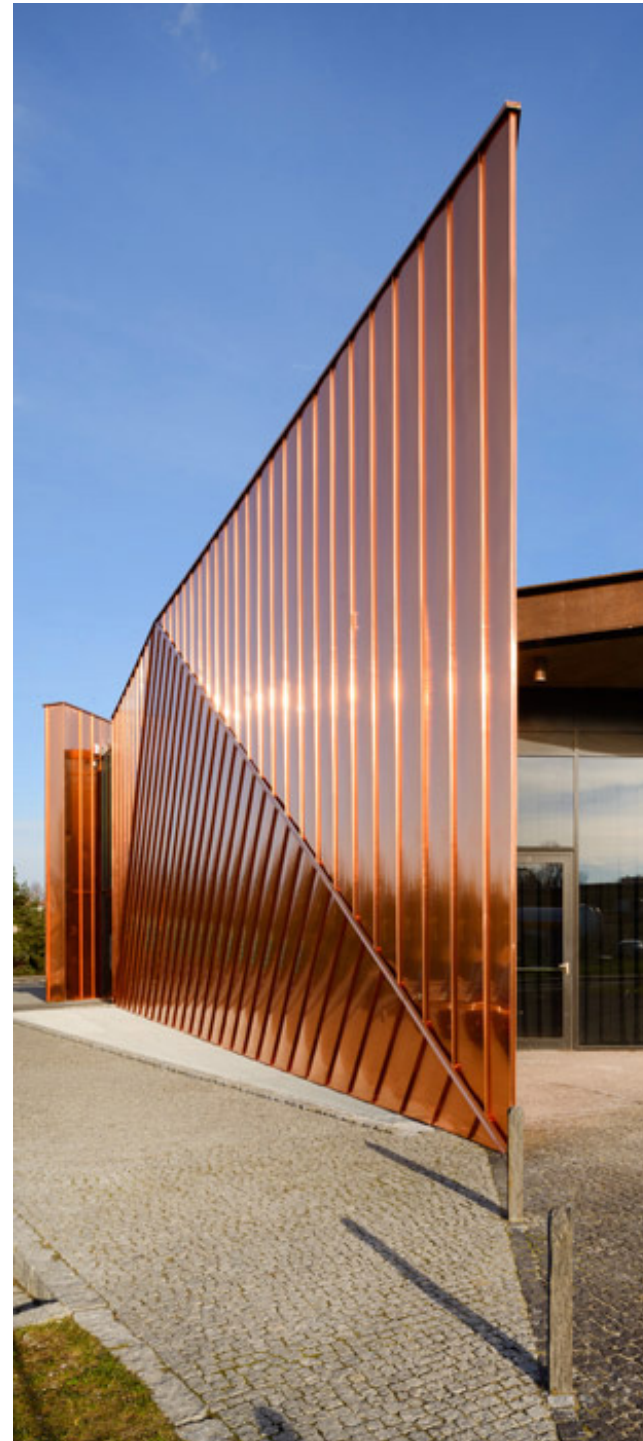
**Material of interest:** Patina Resistant Copper

**Application:** Exterior

**Properties of material:** The patina resistant copper, which is coated in a layer of transparent varnish, remains polished all year long and throughout differing weather conditions. This results in a constant glow that represents fire both in form and color to persist.
